# Manhole Inspection Summary

Manhole # S06AA2022MH

**Location** Address: **3907 BROOKHILL RD**

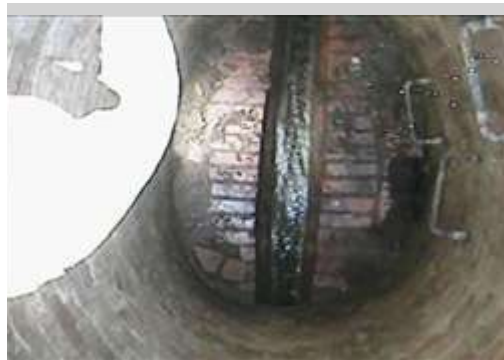
Top View

Adjustment, Corbel, and Barrel infiltration.  
Evidence of surcharge - Bench debris.

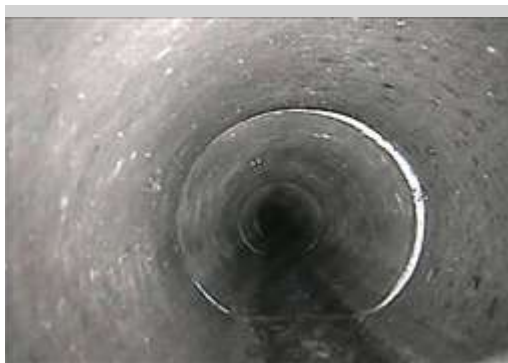
Inside of the O12

Offset joint.

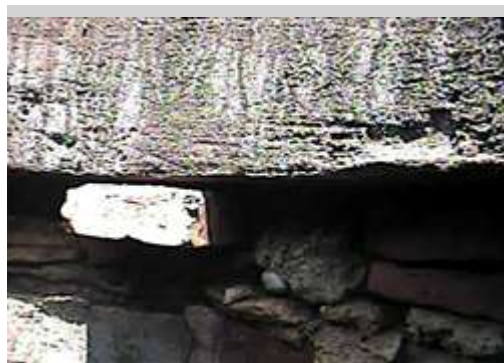
Defect

Frame leaks. Adjustment deterioration  
and loose brick. Adjustment infiltration.

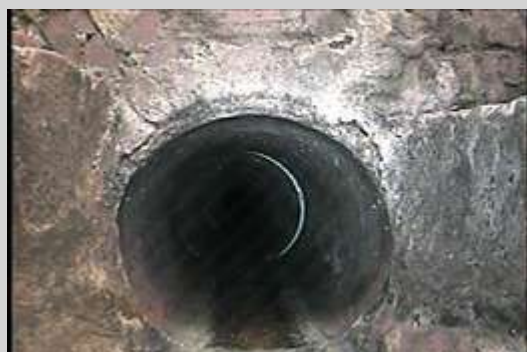
Pipe Out @ 12 O'Clock

Deposits: ☐ None ☒ **Mud** ☐ Sludge ☐ Debris ☒ **Grease**

Silt Depth: **0** (in.) Deposits Extent: **Light**

Infiltration: **Evidence** Pipe Seal Cond: **Cracked**

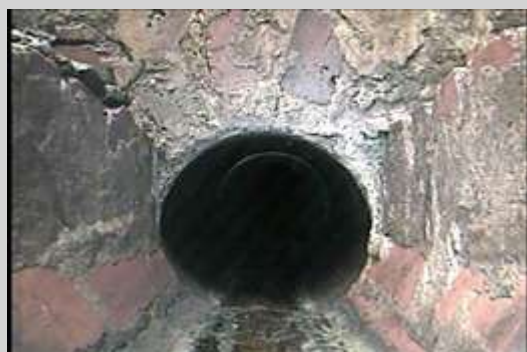
Pipe In @ 6 O'Clock

Deposits: ☐ None ☒ **Mud** ☐ Sludge ☐ Debris ☒ **Grease**

Silt Depth: **0** (in.) Deposits Extent: **Light**

Infiltration: **Evidence** Pipe Seal Cond: **Unknown**
